HISTORIC STRUCTURE REPORT

NHL FERRYBOAT EUREKA

National Park Service | September 2022 - 100% Final

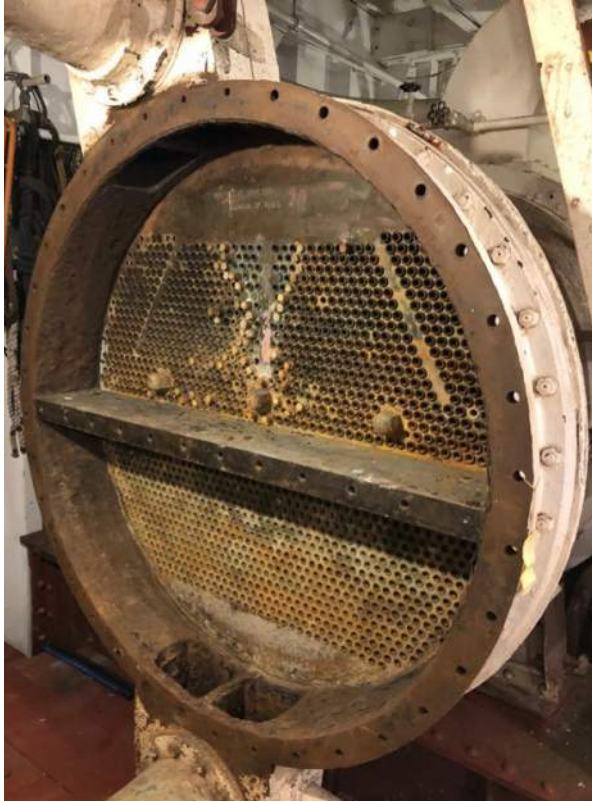
Steam Condenser (Anthony Guild, 2022)

steam that had expended its heat and had returned partially or completely back into water (condensate). The steam condenser helped finalize this part of the steam cycle and then the condensate was transferred to the hot well, where it eventually reentered the boilers as feed water. A small percentage of the tubes have been plugged, likely due to tube failure. This was a customary type of temporary repair to prevent saltwater contamination of the condensate system when a tube failed in service.

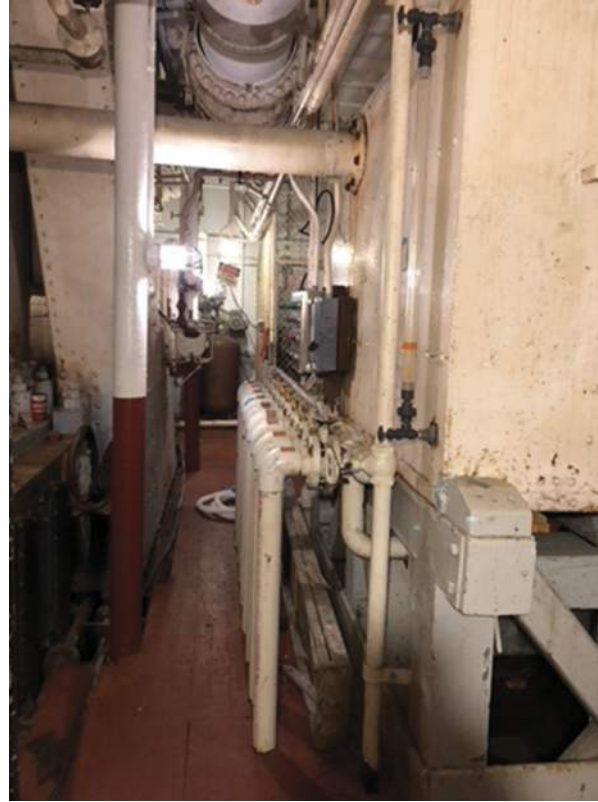
Contemporary PVC Bilge Manifold (Anthony Guild, 2022)

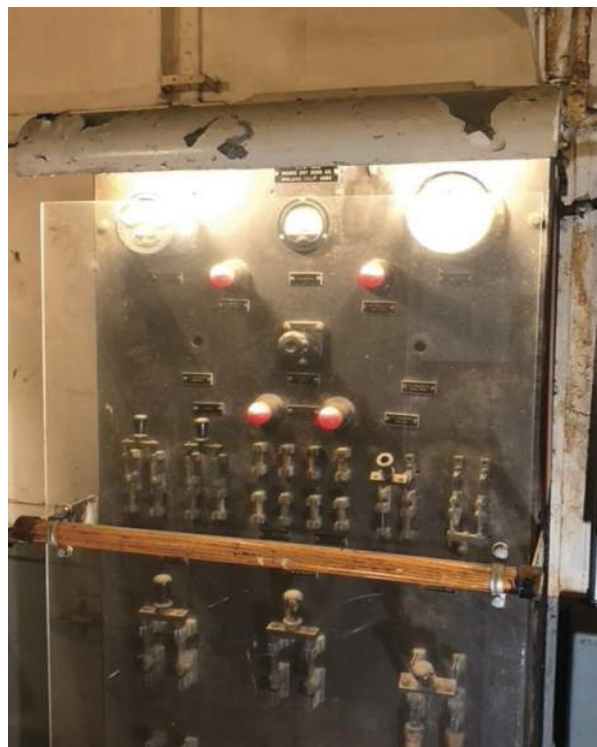
The vessel's DC electrical switchboard is located on the car deck just forward of Dynamo No. 2 inside the machinery enclosure. Access to this location is through a heavy-duty metal screen steel door from the starboard side of the vessel. The DC switchboard is no longer in service. It has been covered in clear plastic and is illuminated so the switchboard equipment can be viewed from the car deck. The original brass knife switches that were used to turn the ship's DC electrical equipment on and off are visible. An AC panel board is located immediately forward of the DC switchboard.

DC Electrical Switchboard (Anthony Guild, 2022)

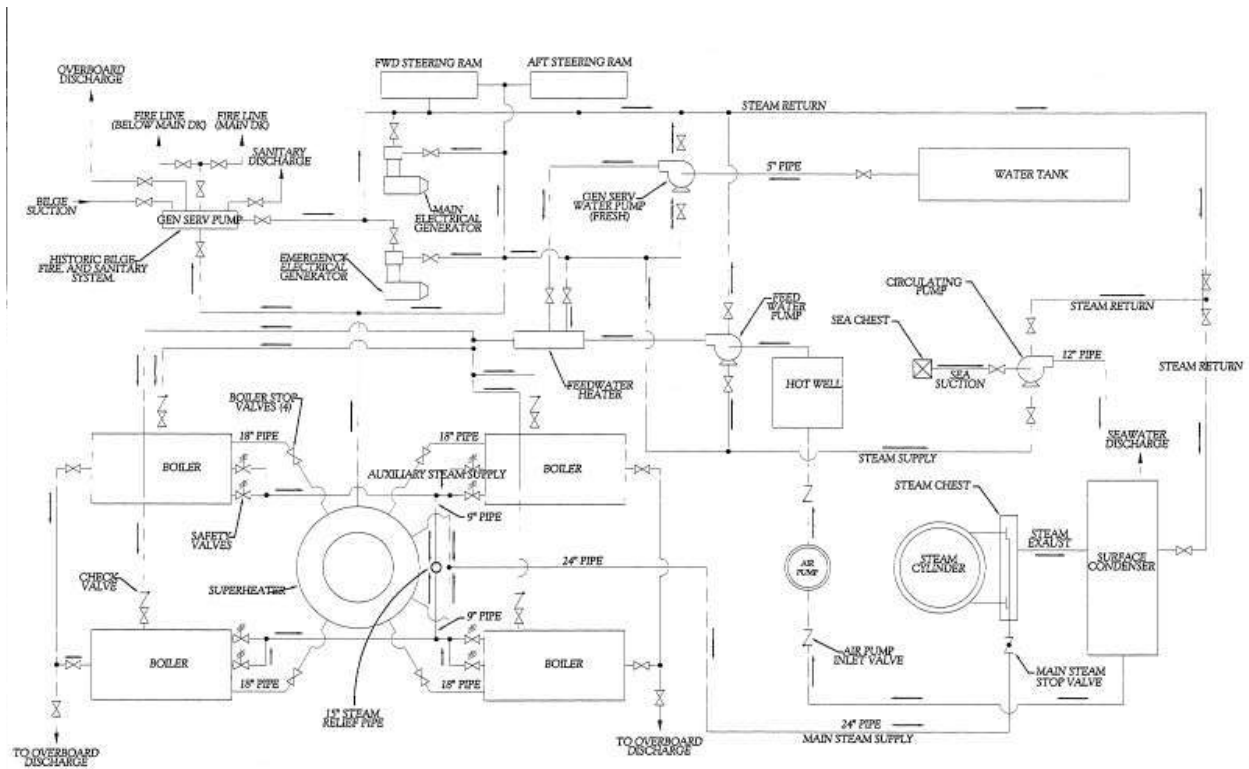
Steam piping configuration (Eureka HAER documentation by Tri-Coastal, 1990)

Steam piping runs throughout the vessel to all the steam driven machinery. Piping components to the fuel service pumps and steam fuel heat exchanger are missing.

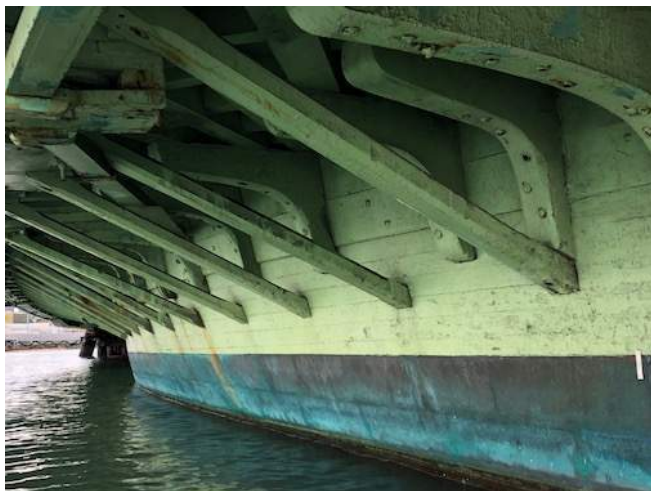
Photo 1: Hanging Knee & Sponson Braces

The Steamer *Eureka* is a traditional heavy-timber plank-on-frame vessel propelled by a walking-beam steam engine driving side paddle wheels. The vessel was originally constructed of Douglas Fir with double-sawn frames approximately 25" on center (O.C) and having a molded dimension that varies from 9" near the sheer line to 14" below the waterline. The vessel has overhanging sponsons that are supported by alternating hanging knees and support braces on the hull's exterior. See Photo 1.

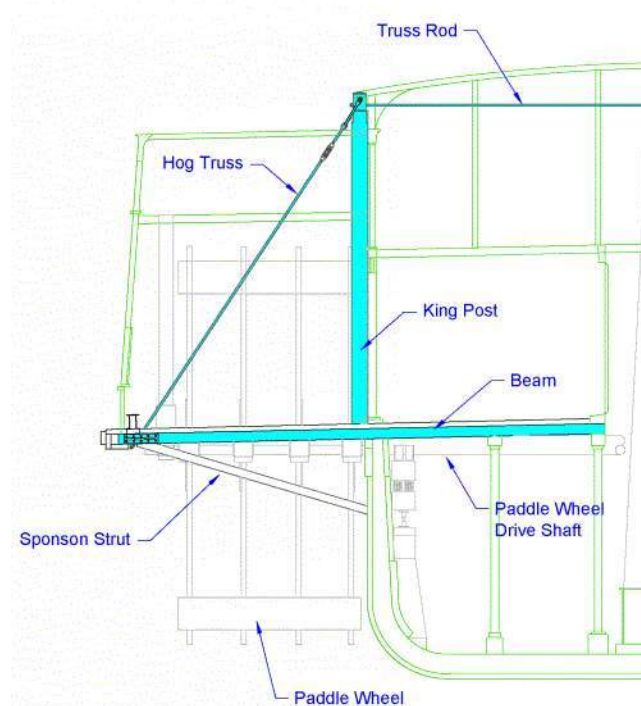
Figure 1: Paddlewheel Truss Support Details

Figure 1 has advanced rot. The decay on this beam has advanced to the point where the end of the beam has lost all strength and is caving in. This condition is affecting the strength of the entire truss structure and paddle box support system and must be repaired as soon as possible.

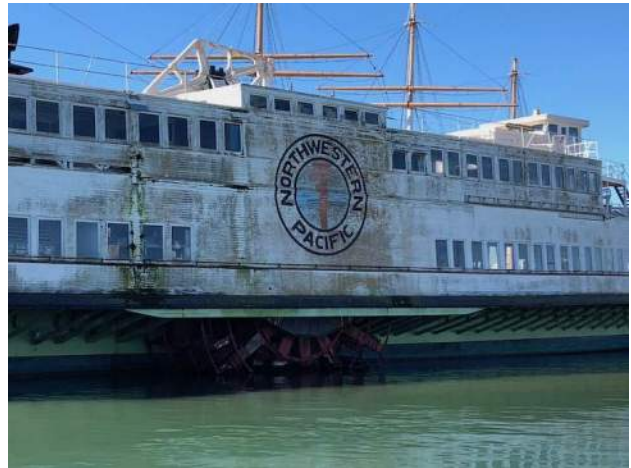
Photo 2: Exterior of Outboard Side of the Eureka

The last thirty years on the *Eureka* are rather expected in terms of how the vessel has aged. Although Park Service personnel are continually conducting maintenance on the vessel, there are limitations to what can be accomplished with the in-house resources and capabilities located at the park. Generally, the condition of the vessel suggests that even keeping up with the cosmetic appearance of the vessel is a challenge with the present allotment of resources. An example of this can be observed by examining the outboard exterior of the vessel (See Photo 2), which reveals early-to-advanced stages of decay in some locations and a considerable growth of moss on the tongue and grove exterior. Rotating the vessel at the moorings periodically would help to ensure maintenance to the outboard side is not deferred to periodic drydocking of the vessel.

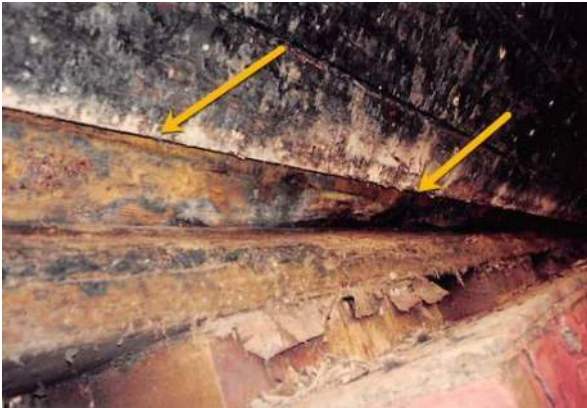
Photo 3: Planks that fell off boat in 1993

Photo 3 above shows the hull in drydock. The yellow arrows are pointing to a portion of the Garboard plank, which is missing. The timber under the missing plank is the keel, which is shown resting on the dry dock blocks.

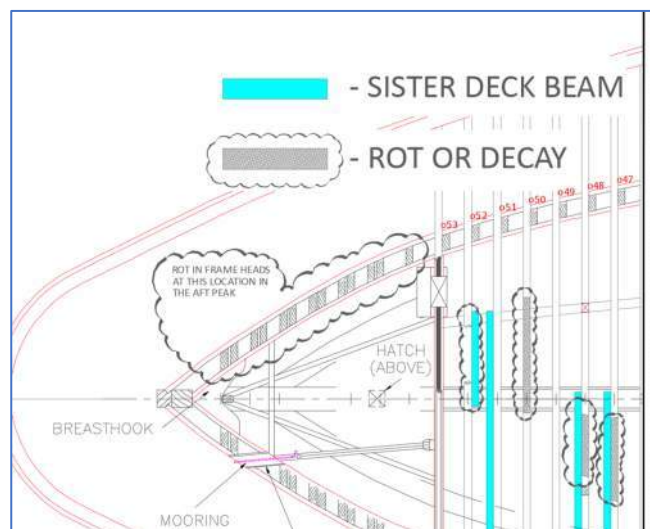
Figure 2: Illustration of Rot in Aft Peak Frame Heads

This temporary deck provided good access to the upper and lower clamp and of the vessel from the collision bulkhead to the bow. The first strake of ceiling (inside planking) below the upper and lower clamps on the starboard side had previously been removed allowing access to the underlying structure. Specifically, the missing ceiling strake allowed access to the frame heads for frames o54 through o61. The forward and aft portions of the remaining ceiling plank ends showed signs of excessive decay indicating one possible reason the section of ceiling had been removed. Frame heads on all visible frames (o54 through o61) as illustrated in Figure 2 were showing signs of advanced decay. M.C. was recorded at or above 26% although the wood was not visibly wet⁴. When probed, the wood was soft and, in some cases, caved in under the lightest pressure. Likewise, when sounded with a hammer the wood easily deformed. Several fasteners were able to be examined in way of the removed ceiling and were found with moderate to severe corrosion. Several bolts heads were sounded, and some held solid while others displayed severe loss of strength. Two (2) were removed due to extensive corrosion and for further examination.

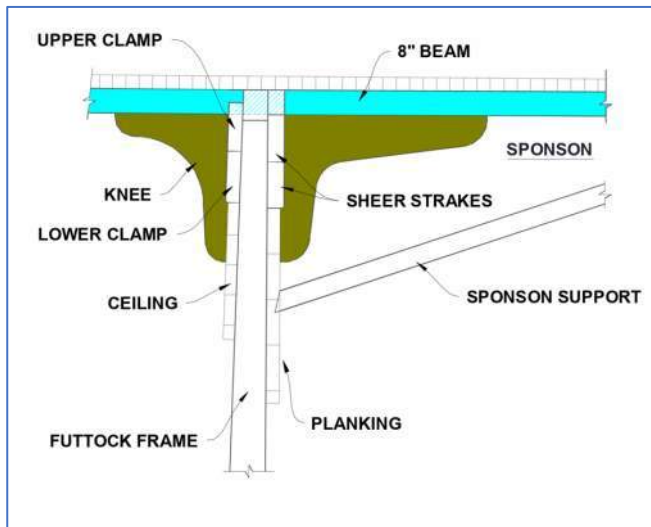
Figure 3: Illustration of Sponson Section

The upper and lower clamp timbers (Figure 3) surrounding the exterior hanging knee fasteners were sounded and revealed solid to soft wood. This indicates defects under the surface of some portions of the upper and lower clamps. Defects were confirmed in some areas with probing and when the hammer used to sound the clamp timbers some areas caved in indicating a serious loss of strength in some of the timbers. While the cause was not identified, the condition is consistent with rot, iron sickness or a result of, and a byproduct of corrosion to the metal fasteners in the area surrounding the fastener in question.

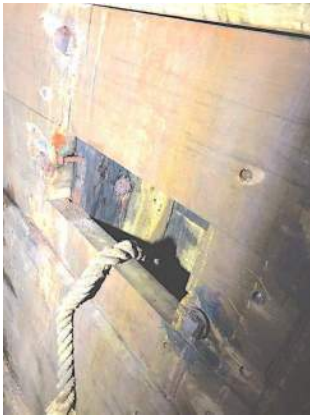
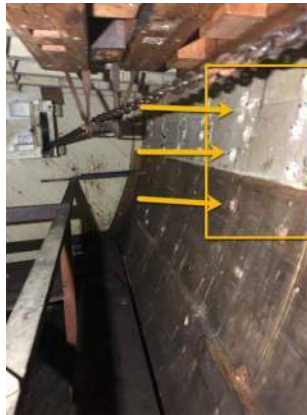
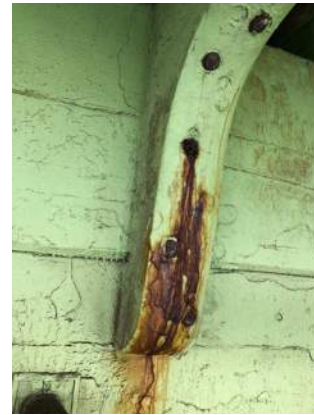
shearing in two. See Photo 4, Photo 5, and Photo 6 for reference.

Upon examination of the removed fastener, it was observed that the bolt was necked down to 0.38" from its original diameter of OOA 0.75". This fastener was submitted to Anamet Inc. who provide materials engineering analysis and laboratory testing services, which includes materials failure analysis, mechanical and metallurgical testing, and chemical analysis. See Section A.9 for additional information on the vessel's fasteners including details from the Anamet report.

Photo 4: Fwd Peak Ceiling

Photo 5: Exterior Knee Fasteners (inside view)

Photo 6: Hanging knee bleeding fasteners

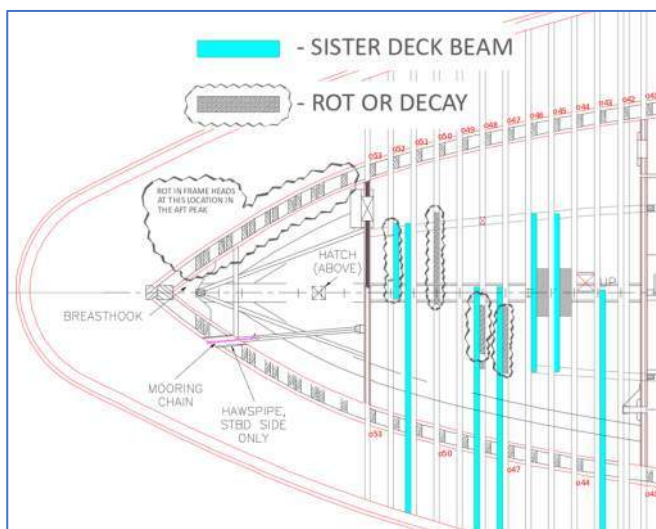
Figure 4: Location of Decay on Beams in Hold #6

Condition in Dec 2019: The hull above the t’ween deck was found in fair condition. The temperature and humidity of the space are as indicated in Table 5. The decay noted in the deck beams in 1990 remains or has worsened. The deck beam above the collision bulkhead for some length is completely missing due to advanced rot. Other beams are experiencing varying degrees of decay and are soft when sounded with the face of a hammer in and beyond visible decay. In one case the beam was probed, and a stream of water was released from the timber.

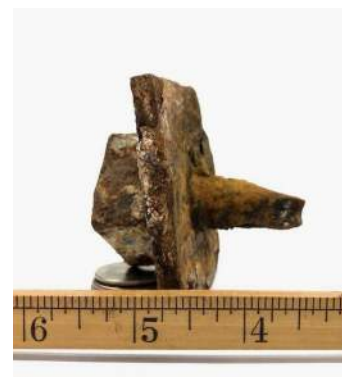
Photo 8: 7/8” Diameter Corroded Bolt

Almost all of the visible fastening ends in the space were observed with a buildup of white crystals substance on and around them. The wood surrounding these areas in some cases was punky and soft indicating a loss in the strength of the wood fibers or weakening of the wood adjacent to the fastener. Additionally, the sea chest on the Port side of the compartment was also found with soft wood surrounding the thru hull valve. See Photo 9. Note that this thru hull fitting has been blanked on the exterior hull.

Several double-sawn frame futtock-bolts were sounded with a crescent wrench and found to be in a weakened state. One end of the fastener turned while the opposite end remained stationary. In one case, with very little force the fastener sheared in half and was extracted revealing extensive corrosion of the fastener. The fasteners in question were originally a 7/8" diameter carriage bolts with a washer and square nut. Both fasteners failed within 3" of the nut side of the fastener.

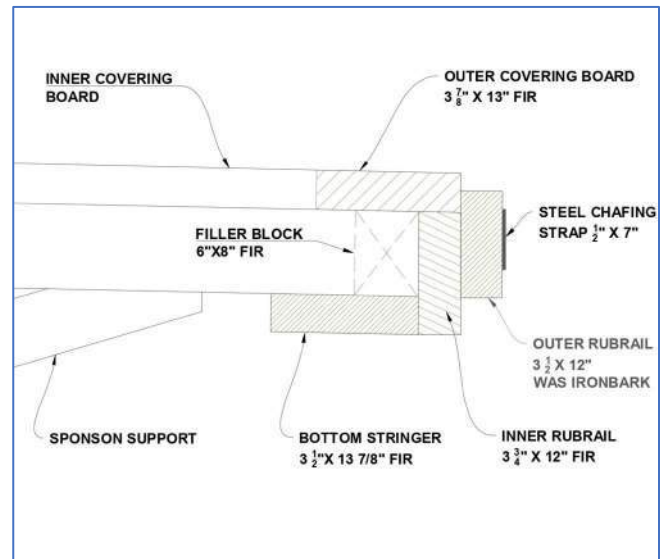
Figure 5: Details of Rub Rail

These beams are designed to support the rub rail and apron outside of the bulwarks, which is further supported with hanging knees and sponson support timbers (see Figure 5). Notably the rub rail was observed (Figure 5: Details of Rub Railing) to be in extremely poor condition and many of the hanging knees were found with checks between fastener, running rust emanating from the fasteners (Photo 6) and some when sounded were hollow, an indication that they may be rotted in the center. Most of the decking on the center of the sponson decks appears to be in good condition; however, due to the extensive rot outside the bulwarks it is likely that much of this structure will require extensive reconstruction and stabilization during the vessel's next yard period.

2.6.3. Replacement of approximately 20 deck beam ends on each side of the vessel by scarfing to previously approved NPS Standard. These deck beams are currently suffering from advanced decay at their ends where they form the vessels rub rail, see Figure 5: Details of Rub Rail.

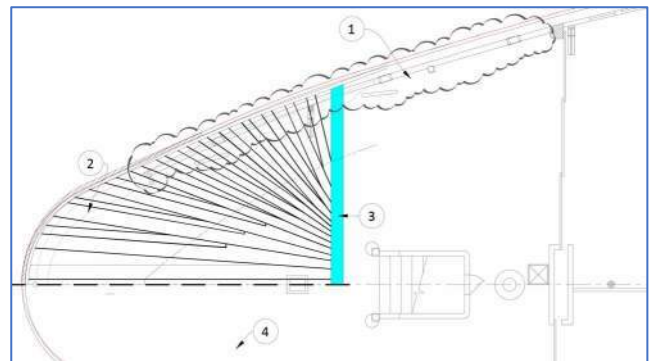
Figure 6: Radiating Fan Timbers

As noted earlier, both the forward and aft radiating fan timbers supporting the sponson decks were found to be in good condition; however, the outer edges of the deck at the bulwarks was found to have advanced rot. Importantly, during the 1994 rebuilding of the fan ends the timbers supplied to the government for this work were reported to have been treated with pentachlorophenol. The wood was government supplied surplus, approved by the National Park Service Western Region Safety Officer.

Item 1: Area with advanced rot. 2: Fan Timber Deck Beam - supporting sponson deck 3: Transverse support beam, 4: Deck

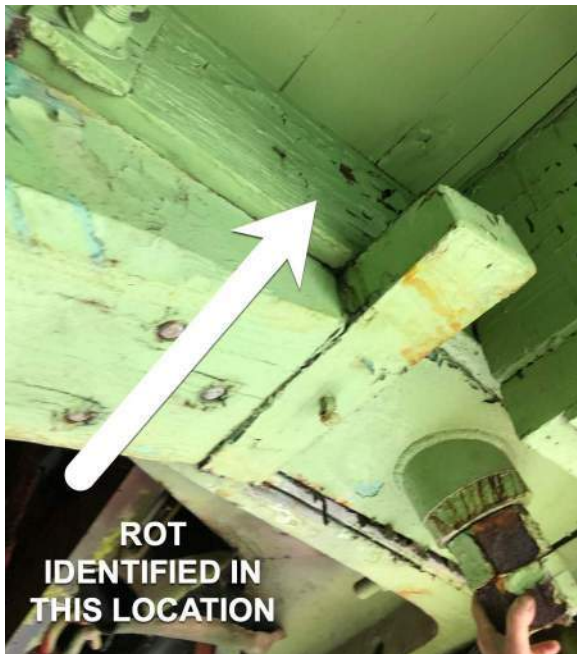
Photo 10: Rot Pocket Under Hog Truss

The Hog Truss lower support beam on the starboard side aft as noted in Photo 10 and illustrated in

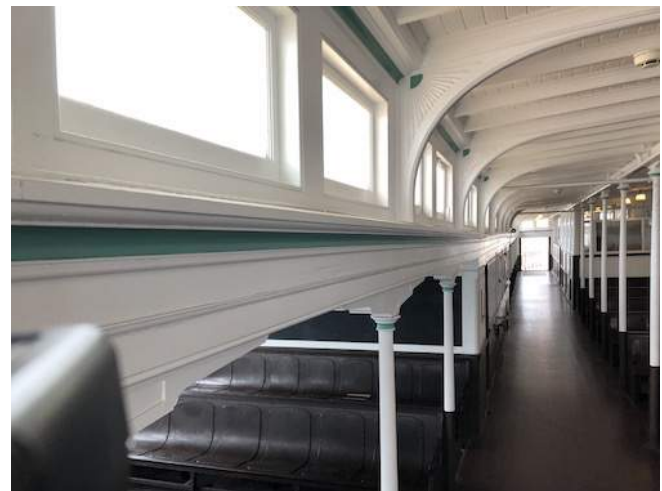
Photo 11: Dome Support Beams

The passenger space is fitted with a domed overhead that extends approximately 3' above the normal ceiling. This gives the illusion of an open space due to the lofted ceiling. The domed ceiling is supported with a longitudinal beam on each side of the compartment that runs the entire length of the inside passenger space and forms the header for the bulkhead that separates the bathroom (heads) on each side of the vessel. The centerline of this space is supported by the steel bulkheads that separate the machinery space from the passenger compartment. The remaining portions of the beam are supported with stanchions that separate the passageway with the spaces fixed seating. See Photo 11 below.

Notably, the beam on either side of the passenger deck is not fair⁵. The condition can be described as sagging. Most of the sagging appears to occur on each side of the structure that surrounds the male and female heads and upper paddle wheel structure, both which have significant structural problems. The roof above or deck on the hurricane deck in these areas is displaying signs of movement between the faying surfaces of the structure, which is also indicative of a problem in the structure.

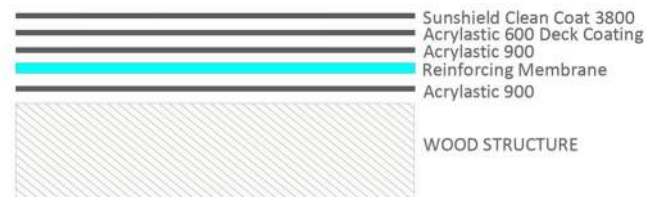
Figure 10: Roof Membrane and Sealing

The material being used is similar in all respects to that described in 1990 and appears to be holding up fairly well. The product is manufactured by Davlin Coatings of Berkeley, California. The products were a composite of reinforcing membrane

sandwiched between Acrylast Asphalt 900. After that sets the area in question is coated with Acrylast Asphalt 600 deck paint and the topcoat is Davlin Sunshield 3800. See illustration in Figure 10.

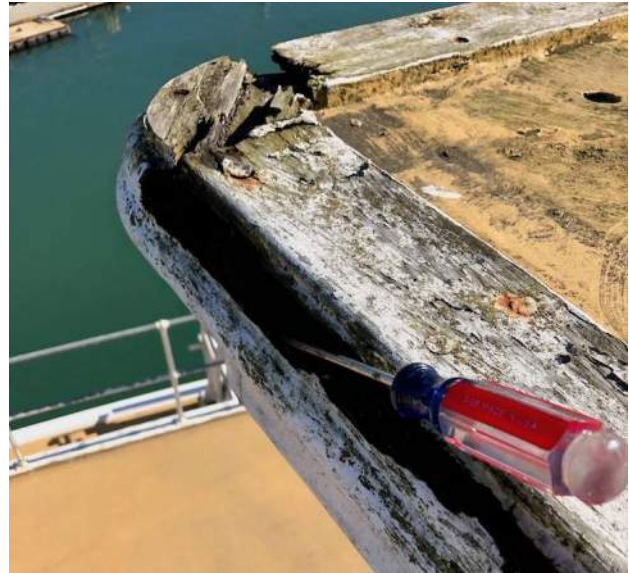
An examination of the forward pilothouse roof showed advanced rot surrounding the covering board around the periphery of the roof membrane. Moss is growing on the membrane; there were elevated moisture readings around the accessible portions of the roof; and the wood under the waterproof membrane was soft and punky in places from rot. The M.C. on the cabin roof was measured at 10% and overall was found in good condition. Some rot was noticed at the corners under the pilothouse roof overhang, but that rot appeared limited to a small section of the covering board.

Photo 13: Left Rear Corner of Pilothouse Roof

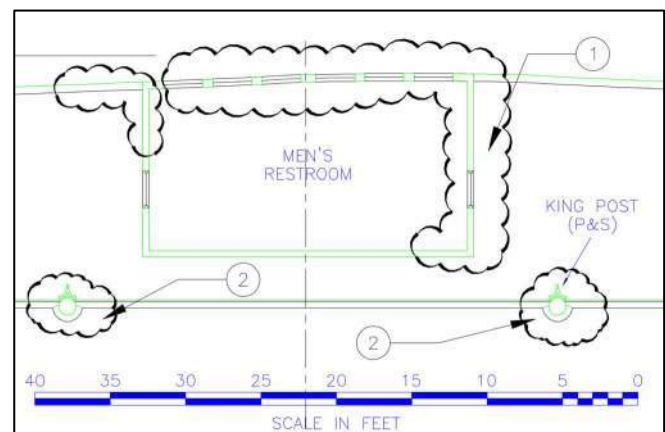
While the male head waterproof membrane appears to be in good condition, there is soft wood under the current membrane and the outer edge of the structure as noted above has extensive rot present. In conjunction with the rot found in the covering board and the observations from 1990 it is highly likely the entire structure will need to be restored. (See Figure 12)

Figure 12: Location of advanced rot in men's head structure

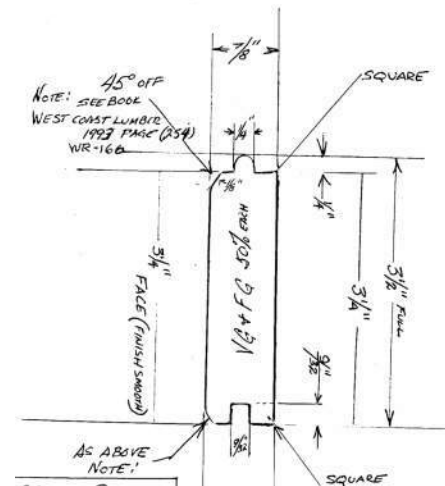
Figure 13: Tongue & Groove Siding Details

The siding covering the paddle wheel box appears to be in worse condition and due to the conditions present it is likely the entire outboard side of the vessel will require extensive restoration and stabilization. Historic records reviewed revealed the siding is cedar T&G as dimensioned in Figure 13.

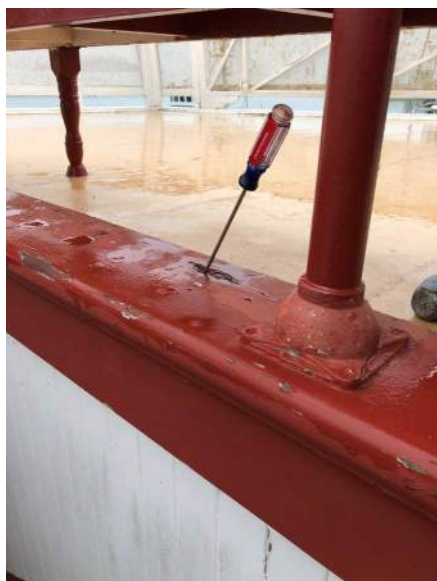
Examination of the aft end (Oakland end) of the passenger deck on the exterior of the vessel revealed some wood defects at the covering boards under the passenger railings. Railings were found in acceptable condition; however, there were pockets of rot present in the cap rail on the outboard side in way of the lifeboat station. Additionally, pockets of rot were discovered in the covering board on the periphery of the stairs leading to the car deck below. See Photo 16 & Photo 17.

Photo 16: Rot in Railing

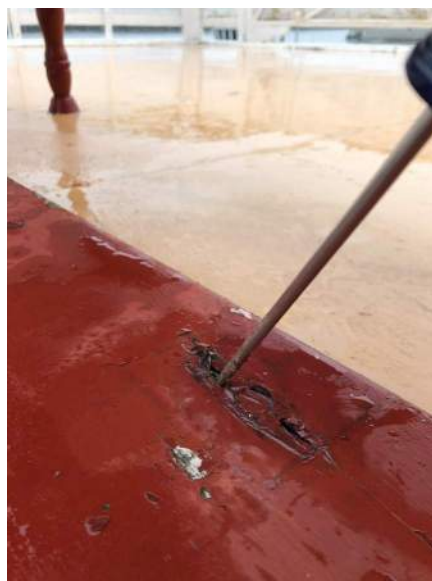
Photo 17: Close up of rot in railing

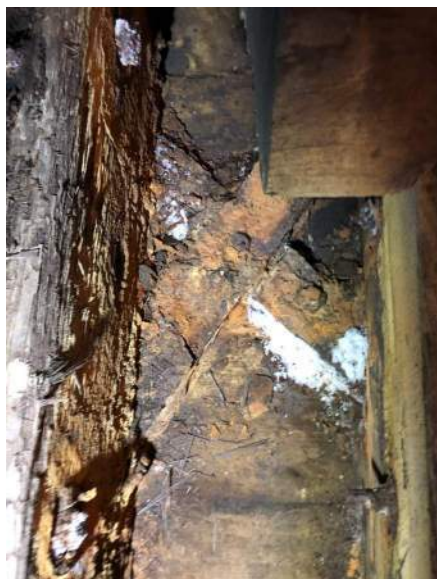
Photo 18: Hogging Strap Corrosion

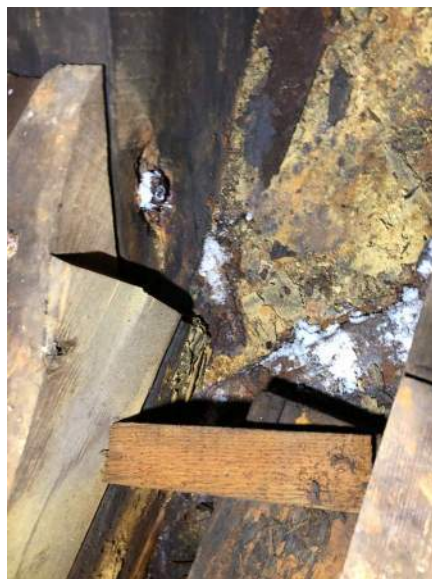
Photo 19: Hogging Strap Corrosion

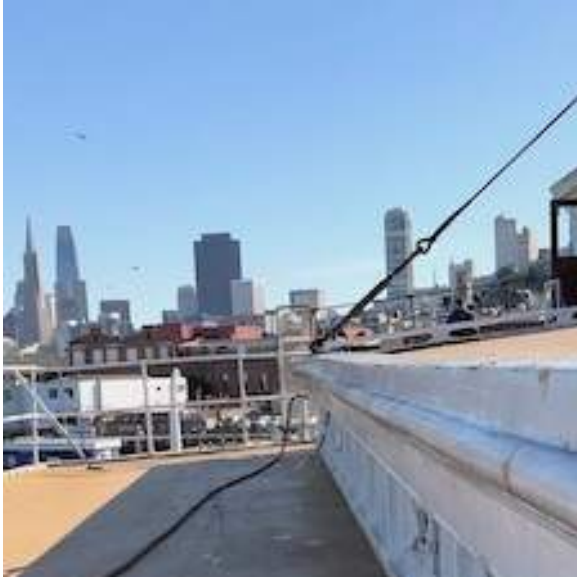
Photo 20: Guy Tension Deforming Roofline

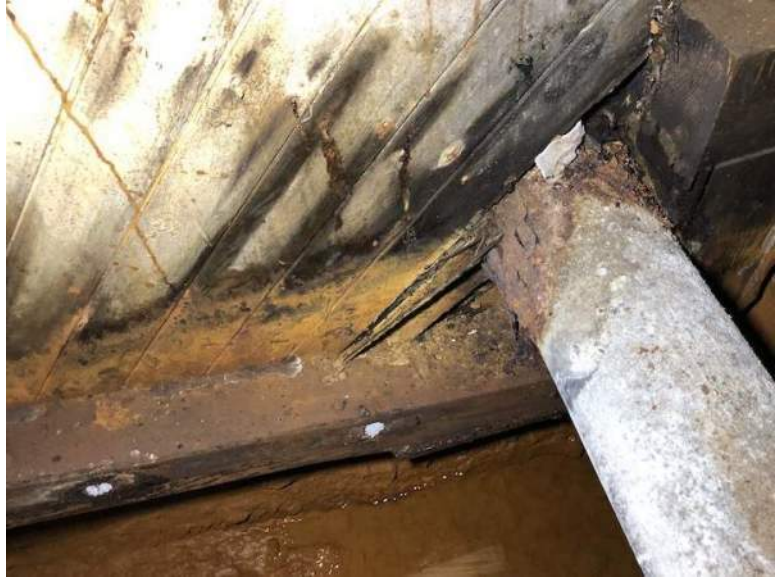
Photo 21: Frame Bulkhead Connection

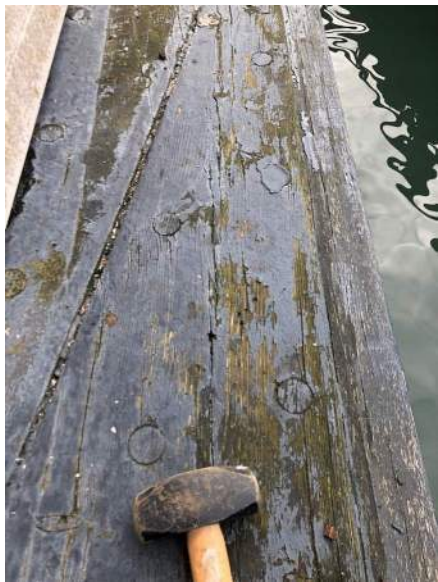
Photo 22: Rub Rail Rot

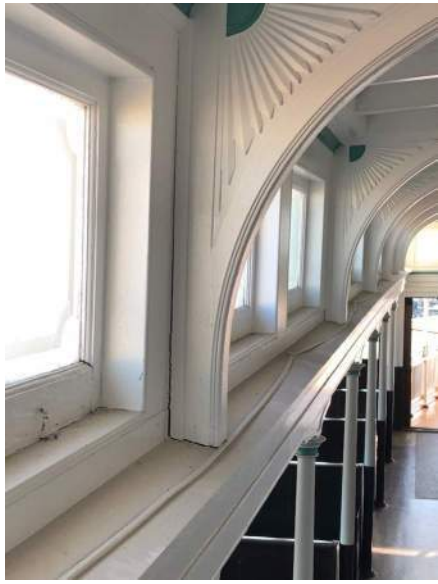
Some movement in the structure's gussets were observed in the transition between the clerestory window structure and the domed roof. See Photo 24. That obvious separation between the faying surfaces is in an area where the roof line is sagging and where elevated moisture readings were present. The location is just above the 6th stanchion on the outboard and San Francisco end of the vessel. This distortion might be caused by the support wire stay for the vessels exhaust stack which appears to be jacking the structure up in an area just aft of the area of concern. Regardless of the reason, the situation has caused separation between the roof membrane and the structure allowing water entry. Sounding the deck (membrane and underlying deck) did not reveal any soft spots however, this area should be opened up during repairs and examined further.

Photo 24: Frame Deformation Around Windows

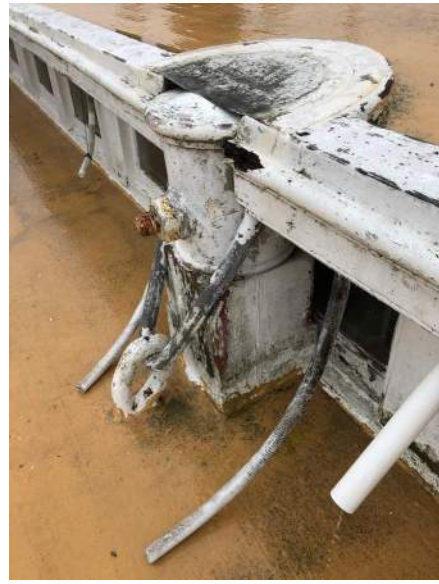
As noted in Photo 12, the covering board wood was found punky and soft with a high moisture reading. See Photo 25.

Photo 25: Covering Board Rot

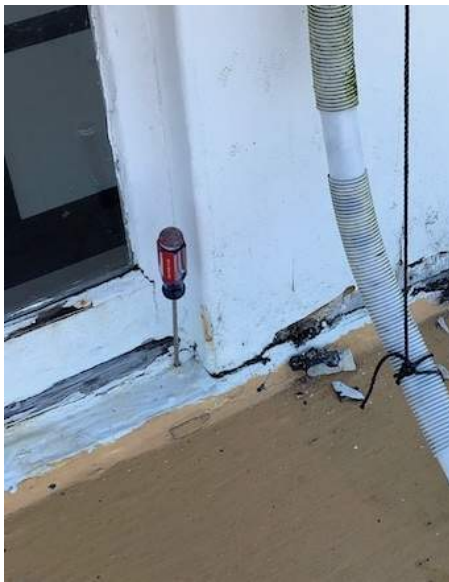
Overall the membrane was found in good condition except as previously noted in the areas where there is separation in the transition to the domed roof. See Photo 26.

The periphery of the domed passenger deck roof is fitted with windows with, in some cases, etched glass. (See Photo 11) The sashes and wood structure surrounding many of the windows was found in sound condition; however, there are numerous window sashes that were observed with extensive advanced decay. Some were so bad that the wood was caving in under its own weight. This condition is a direct result of water not properly draining off the structure and is affecting the underlying structure. (see Photo 26, and Photo 27)

Photo 26: Rot in Deck Window Transition

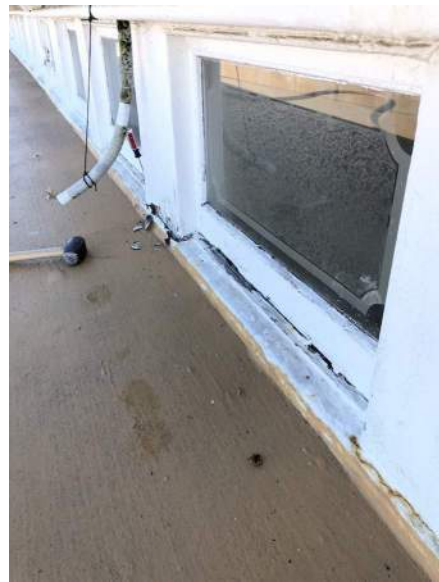
Photo 27: Rot in Sash and Window Support Structure

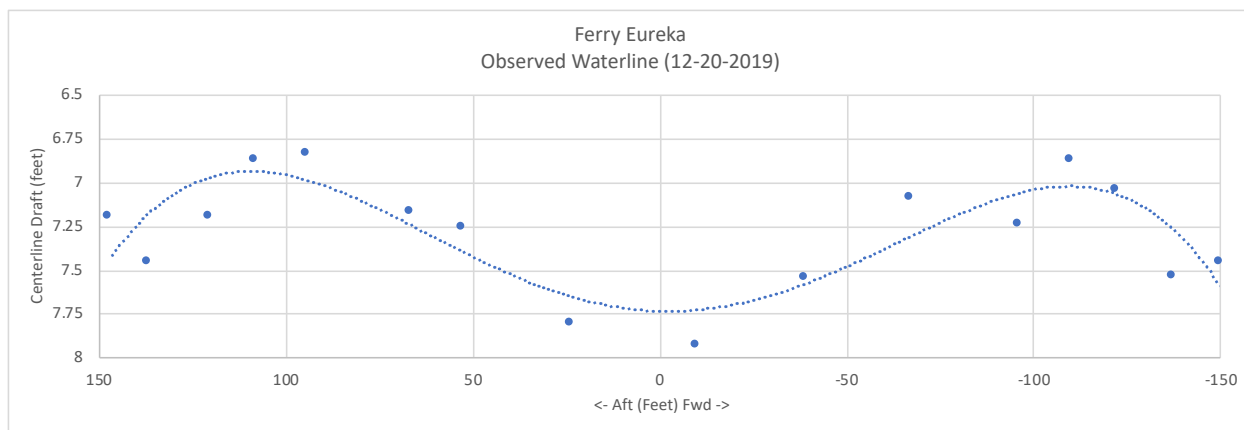
The surveyed freeboards were not measured to the precision required for a stability test per ASTM F1321, however with 16 survey points per side the results do provide a clear picture of hull deflection and a reasonably accurate estimate of the afloat waterline. A plot of the calculated drafts is provided in the figure below. (Note: the vertical scale has been reversed to show sag as down and more clearly represent the curvature of the vessel.) The waterline plot shows approximately a foot of sag amidships, but it also shows substantial sagging of the extreme forward and aft portions of the main deck cantilevered beyond the buoyant hull.

The draft curve was truncated to the buoyant hull envelope for entry into GHS and resulted in a displacement of approximately 1630 long tons and 11-1/4 inches of sag based on a least-squares fit of the draft data. (Full GHS output for these calculations is attached as Appendix A) This calculated displacement is approximately 180 long tons heavier than that reported in 1993. With a tons per inch of immersion (TPI) of 21 long tons per inch, it is possible that some portion of this discrepancy is due to freeboard measurement error, but it is unlikely that across 32 freeboard measurements (16 per side) that the overall data set is 9 inches off. Rather it is likely that the vessel gained weight over the past 25 years. To be conservative, the weight growth was considered to be centered 24 feet above baseline (well above the main deck) and distributed longitudinally over the full length of the deck house.

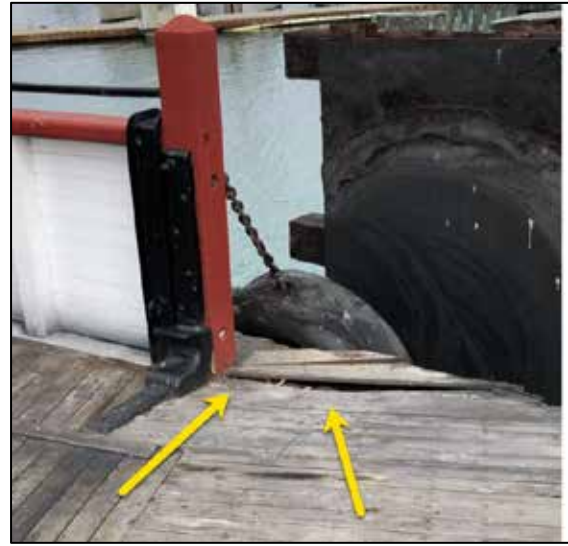
Photo 2

Image of the damage to the main deck in way of the dolphin impact point (2021)

The damage to the port side of the vessel at the bow is now severe. This portion of the vessel has deteriorated to the point that the structure can no longer withstand the constant impacts with the mooring dolphin. (See Photo 2, Photo 3, Photo 4 and Figure 1.) Noticeable structural degradation can be seen when comparing the photographs taken in

The loss of structural integrity due to advanced decay in the rub rail and deck beam timbers is the underlying cause of the damage visible in the photographs. The deteriorated timbers have no remaining strength and were no longer capable of withstanding the vessel's impact with the mooring dolphin (reportedly more severe during the recent inclement weather).

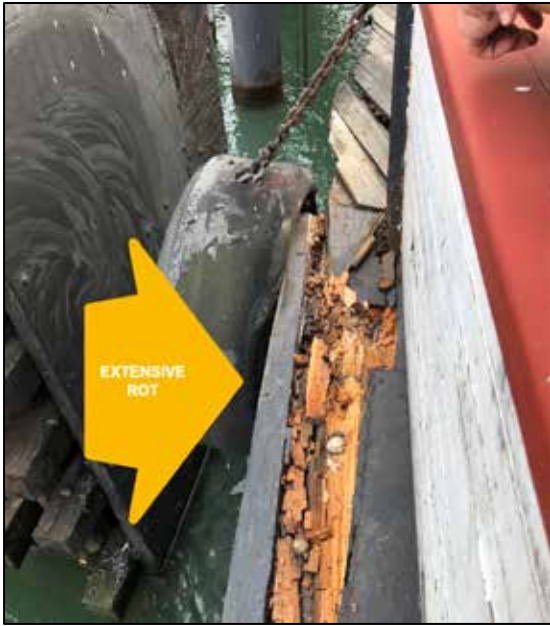
Photo 3

Image of the extensive decay (rot) on the Sponson structure (2021)

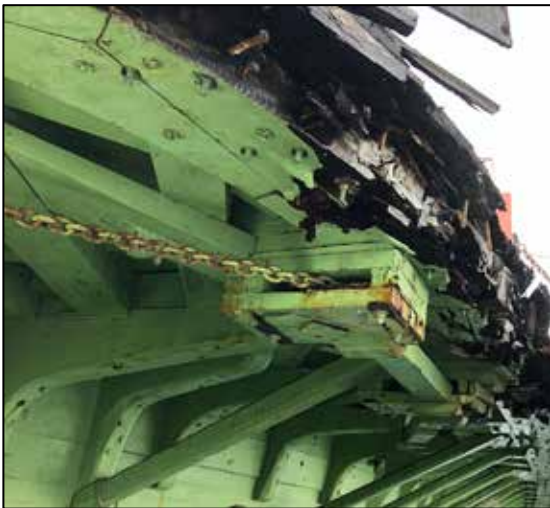
Photo 4

Image of Sponson from the waterline looking up at the impact point of the port SF Side bow (2021)

2020 (Photo 5) versus the photographs taken in 2021 (Photo 4).

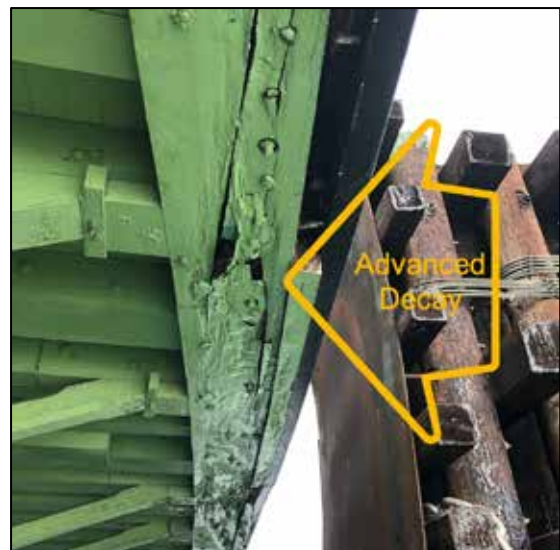
Photo 5

Image of Advanced Decay in 2020

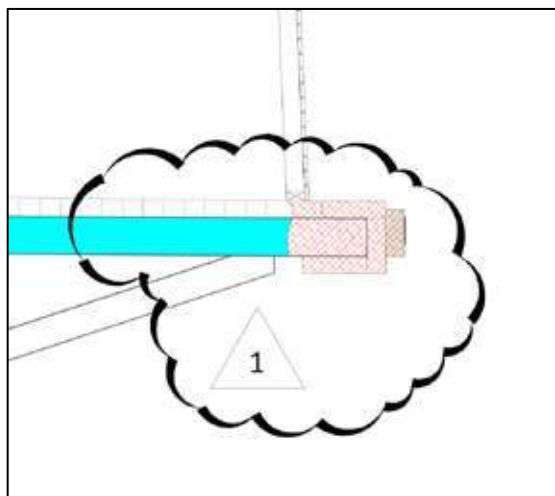
Figure 1

Illustration of the outer Sponson Rub Rail and location of advanced decay (Red Hatch)

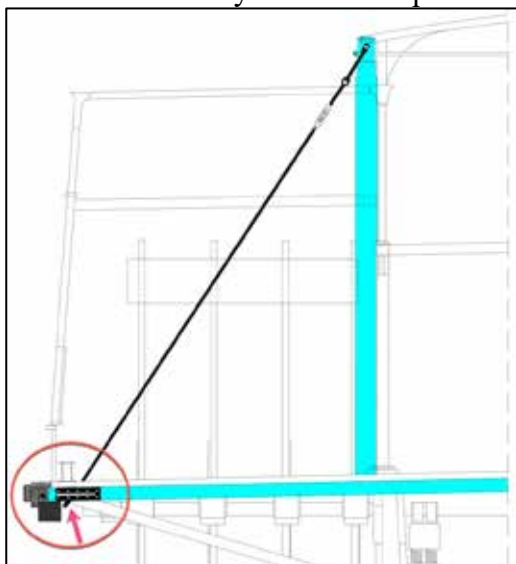
Illustration of the vessel's Hog Truss and outer connection. Note arrow pointing to underside

The aft Hog Truss lower support beam on the starboard side of the vessel as noted in Photo 6, and illustrated in Figure 2 has advanced decay. The decay on this beam has progressed to the point where the end of the beam on the outboard side of the vessel has lost all strength and is caving in. This condition is affecting the strength of the entire truss structure and paddle box support system and must be repaired as soon as possible. See Photo 6.

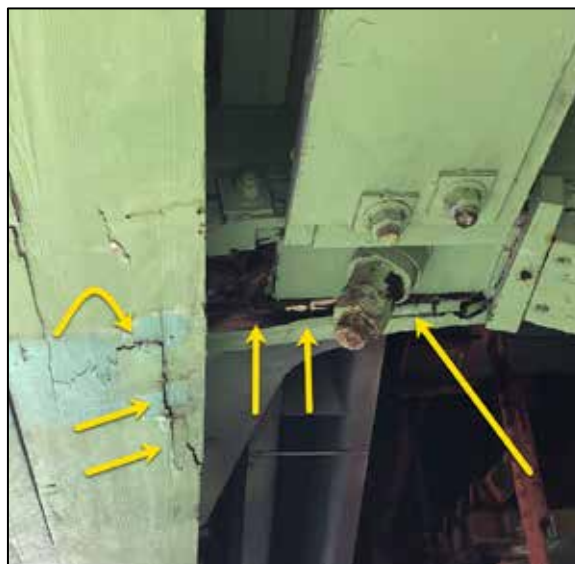
Photo 6

Area under Hog Truss lower rod connection. Area depicted by arrow in Figure 2

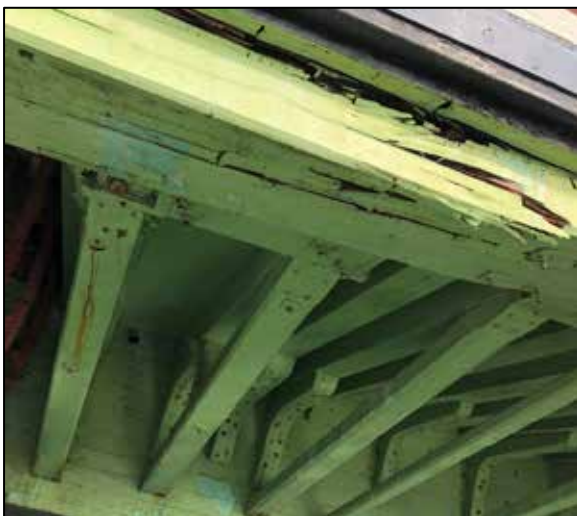
Photo 8

Photograph of area noted in photo 7 from 2021

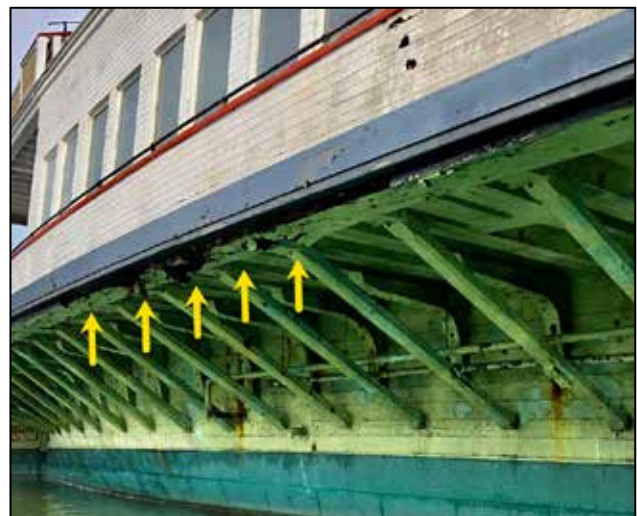
Photo 9

Photograph of advanced decay proceeding aft of the paddle wheel on the starboard side of the vessel

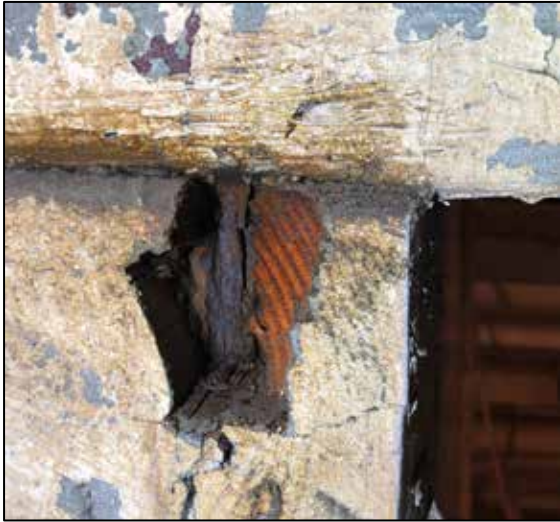
Photo 10, and Photo 11 were taken during the inspection of the fastener in question. Due to the size of the timbers in this location of the vessel, the fastener in question is presumed to be a 7/8" diameter bolt. The bolt seen in the picture is extensively corroded, and the expansion of the resulting rust has damaged the end of the deck beam. The corroded diameter is not evident in the picture, but the diameter has been reduced by more than 80%.

Close up of photograph 11

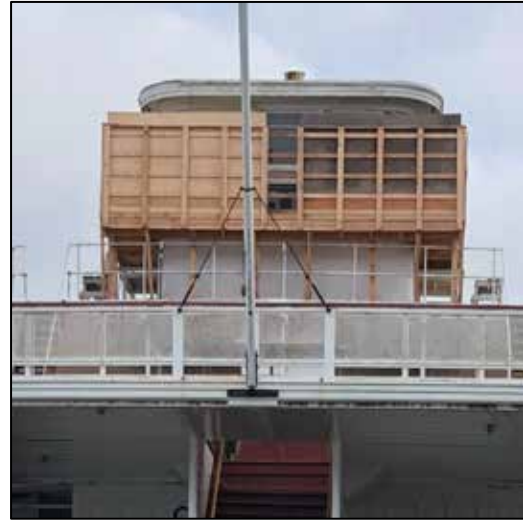
Photo 12

Image of Staging for repairs to the aft pilot house

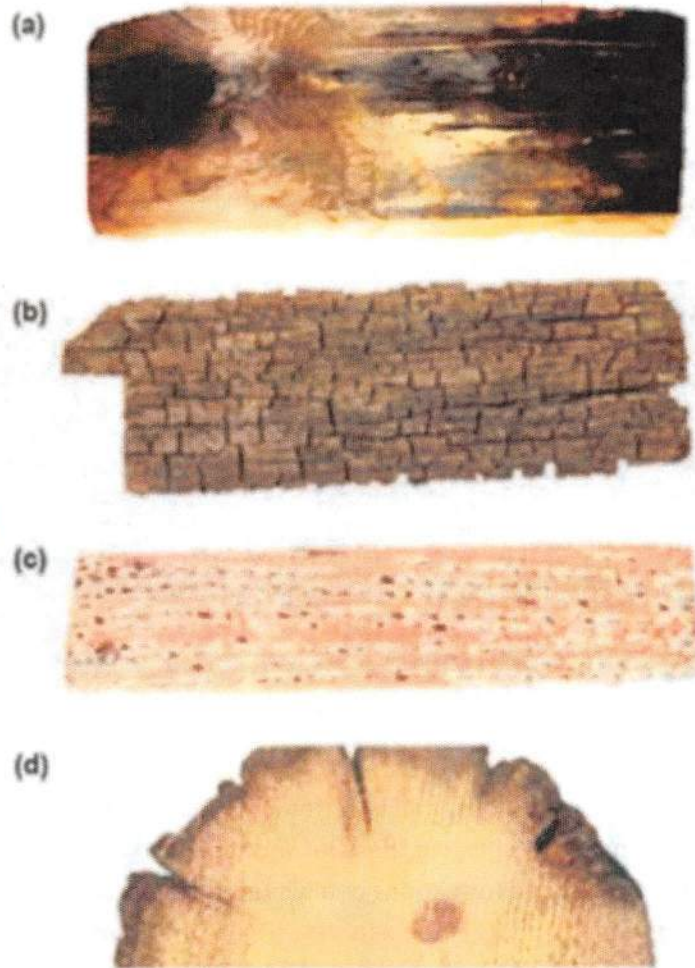
Figure 1: Characteristic images of biodeterioration on wood : (A) mold fungi (B) brown-rot fungi (C) white rot fungi (D) soft rot fungi.

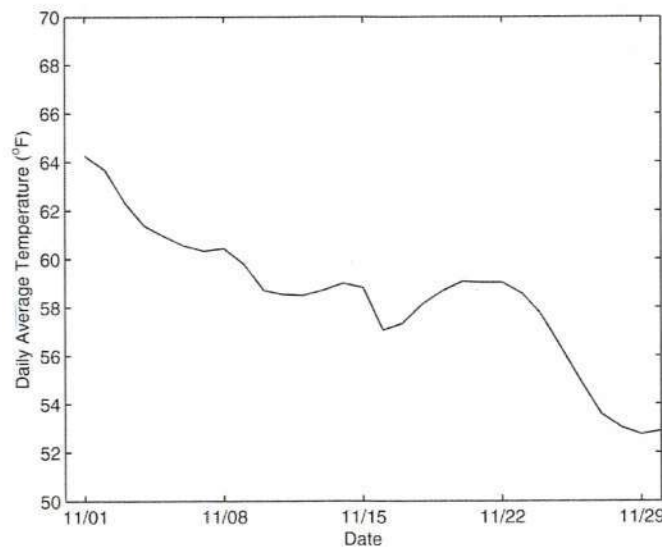
Figure 7 shows the daily average temperature in the forward bilge during the month of November. The temperature differences between the sensors were insignificant so the temperatures were averaged.

Figure 7: Daily average temperature in the forward bilge during the month of November, 2015.

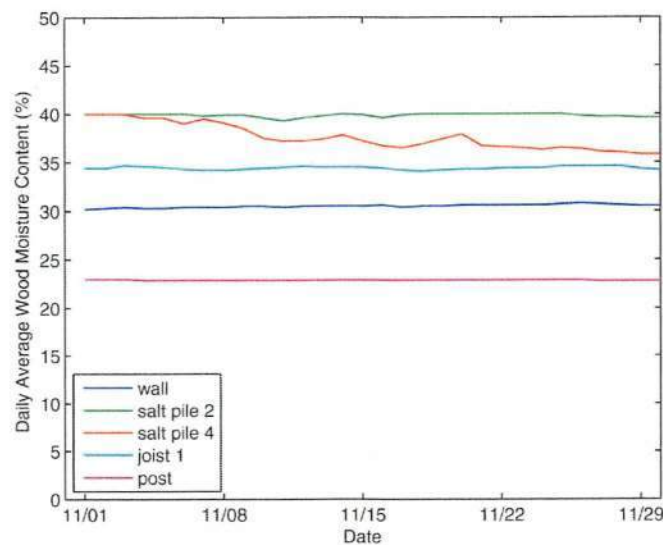
Figure 8 shows the wood moisture content (averaged on a daily basis) at 5 different locations in the forward bilge during the same time period. The sensors cannot read moisture contents above 40%. There was very little movement in the moisture readings throughout the month. All of the moisture readings were high, although it should be noted that the salt in the wood will increase the measured moisture content relative to the true, gravimetric moisture content, by an unknown amount.

Figure 8: Daily average wood moisture contents (measured electrically) during the month of November, 2015.

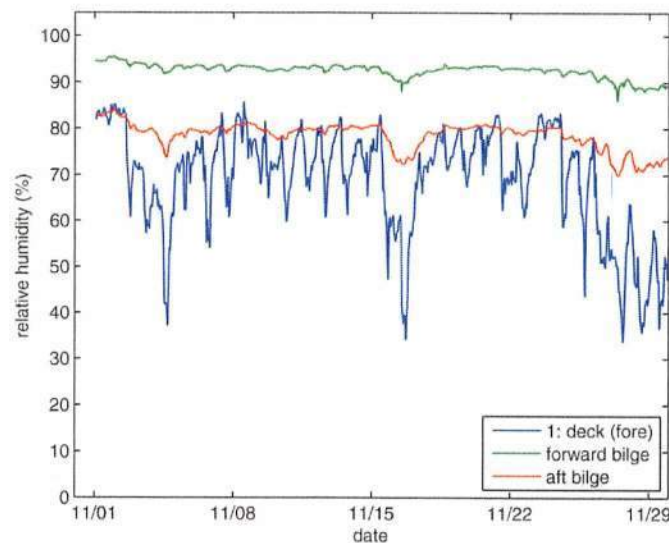
Figure 9 compares the average hourly relative humidity in the forward and aft bilges in comparison with the relative humidity on the deck of the ship. Large fluctuations in the RH on the deck caused some fluctuations in the bilge, however, the fluctuations were very dampened. The variations in the RH in both bilges responded to changes in the relative humidity on the deck in the same way. However, for all measurements, the relative humidity in the aft bilge was lower (by about 10%) than the forward bilge.

Figure 9: Hourly relative humidity measurements on the deck of the ship (blue) and in the forward (green) and aft (red) bilges.
